**Flood Control Project Maintenance
Levee Inspections****LMA District Cover Sheet****Spring 2013 Levee Inspection Results****Tehama County Flood Control and Water Conservation District**

Spring 2013 Levee Inspection Results

Tehama County Flood Control and Water Conservation District

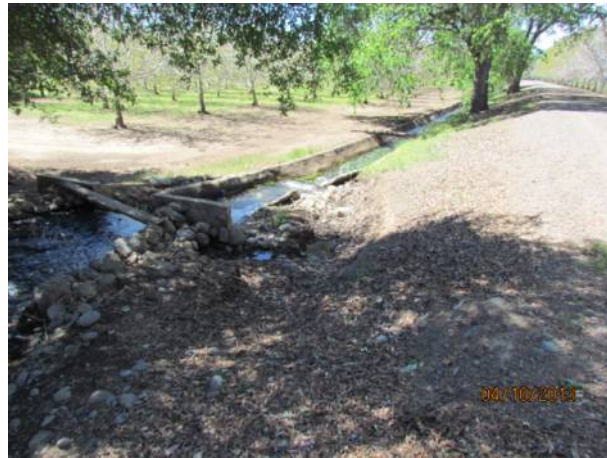
Levee Mile Report Line	4
Start Levee Mile	0.02
End Levee Mile	0.02
Location	Land Side
Category	
Item	Erosion / Bank Caving

View of the erosion along the landside slope.

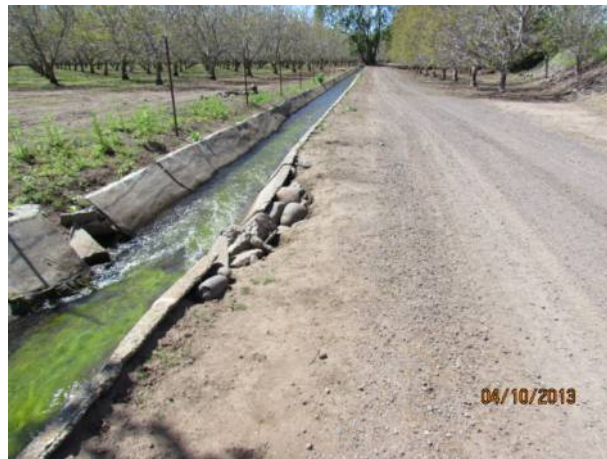
Levee Mile Report Line	5
Start Levee Mile	0.41
End Levee Mile	0.41
Location	Land Side
Category	
Item	Erosion / Bank Caving

View of the erosion along the landside slope.

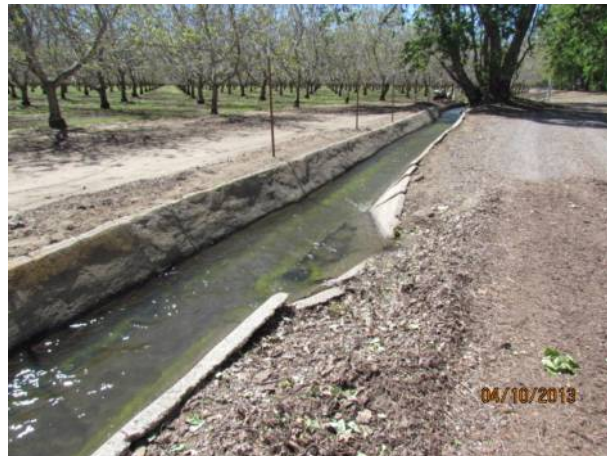
Levee Mile Report Line	6
Start Levee Mile	0.48
End Levee Mile	0.48
Location	Land Side
Category	
Item	Erosion / Bank Caving

View of the erosion along the landside slope.

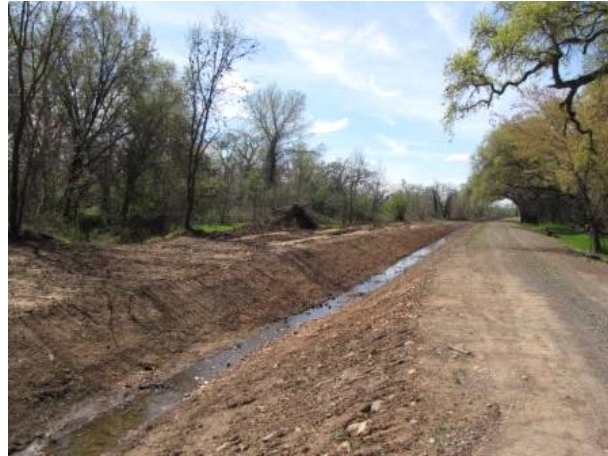
Levee Mile Report Line	7
Start Levee Mile	2.04
End Levee Mile	2.23
Location	Land Side
Category	
Item	Encroachments
Remove agricultural ditch from toe of levee.	
rduffey_s_20130225_157.jpg

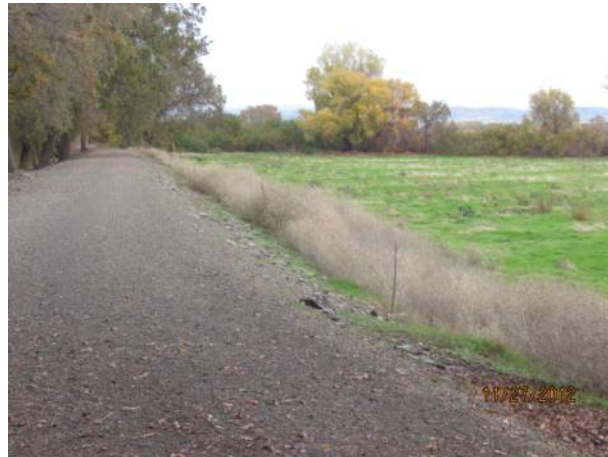
Levee Mile Report Line	8
Start Levee Mile	2.31
End Levee Mile	3.04
Location	Land Side
Category	
Item	Vegetation
View of the vegetation along the landside slope.	
rduffey_s_20130225_158.JPG

DWR ID: DWR_NA0019_01_s_2013_19									
7	2.04	2.23		Encroachments	LS M En	DT : Ditch	39.968387 ° -122.016387 °	39.966968 ° -122.019372 °	2 Y
DWR ID: DWR_NA0019_01_s_2012_2									
8	2.31	3.04		Vegetation	LS M Ma	V2 : Remove the wild growth other than native grasses from the levee slopes.	39.967015 ° -122.020781 °	° ° ° °	3 Y
DWR ID: DWR_NA0019_01_f_2012_3									
9	2.50	2.58		Slope Stability	CR M Ma	S3 : Repair the levee slope damaged by vehicle traffic and prevent access where possible.	39.967016 ° -122.024068 °	39.966455 ° -122.025531 °	7
DWR ID: DWR_NA0019_01_s_2012_7									
10	2.72	2.76		Slope Stability	CR M Ma	S2 : Repair the levee slope damaged by foot traffic and prevent access where possible.	39.965434 ° -122.027776 °	39.965180 ° -122.028331 °	8 Y
DWR ID: DWR_NA0019_01_s_2012_8									
11	2.90	2.90		Slope Stability	LS M Ma	S1 : Repair slope instability.	39.963709 ° -122.030384 °	39.963709 ° -122.030384 °	20 Y

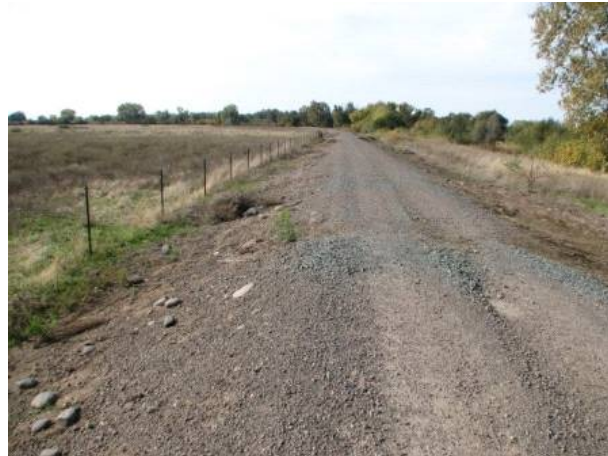
Levee Mile Report Line	10
Start Levee Mile	2.72
End Levee Mile	2.76
Location	Crown
Category	
Item	Slope Stability
Erosion on crown and both slopes.	
rduffey_s_20130225_159.jpg

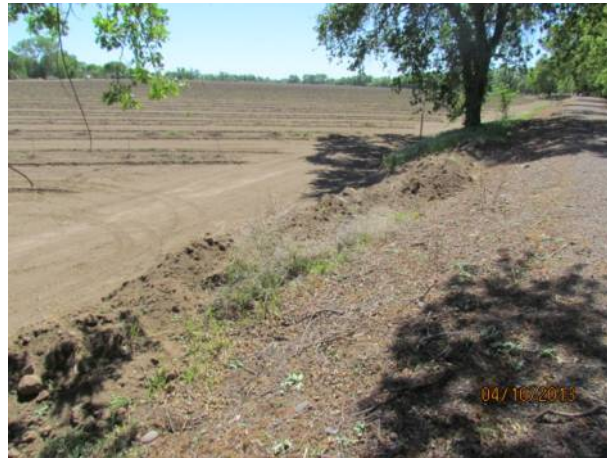
Levee Mile Report Line	11
Start Levee Mile	2.90
End Levee Mile	2.90
Location	Land Side
Category	
Item	Slope Stability

View of the erosion along the landside slope.

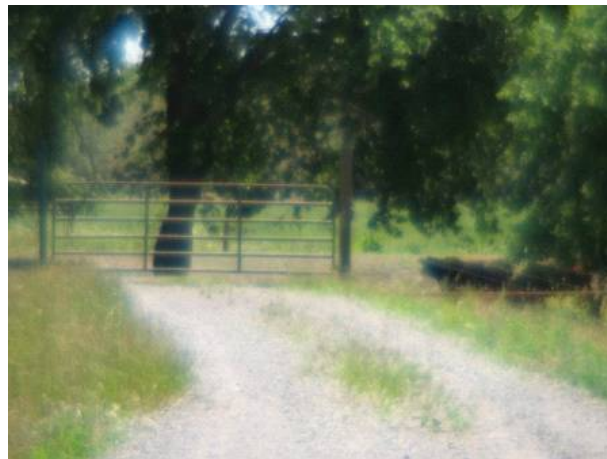
Levee Mile Report Line	13
Start Levee Mile	3.64
End Levee Mile	3.64
Location	Crown
Category	
Item	Encroachments

View of the non-permitted gate on the crown of the levee.

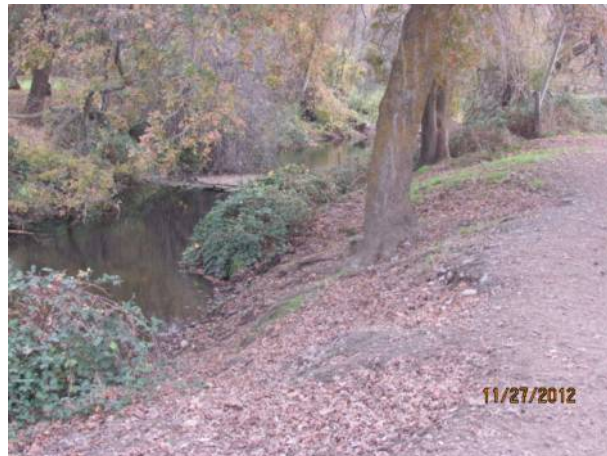
Levee Mile Report Line	14
Start Levee Mile	3.68
End Levee Mile	3.68
Location	Water Side
Category	
Item	Slope Stability

View of the erosion caused by livestock along the landside slope.

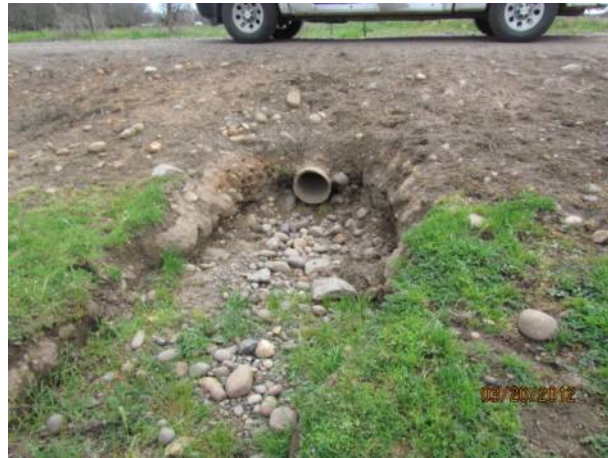
Levee Mile Report Line	15
Start Levee Mile	3.74
End Levee Mile	3.74
Location	Water Side
Category	
Item	Encroachments

No flap gate on 18 inch pipe going to the levee.

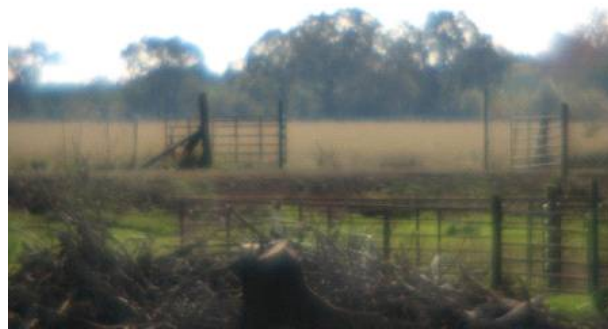
Levee Mile Report Line	16
Start Levee Mile	3.74
End Levee Mile	3.74
Location	Crown
Category	
Item	Encroachments

View of the non-permitted gate on the crown roadway.

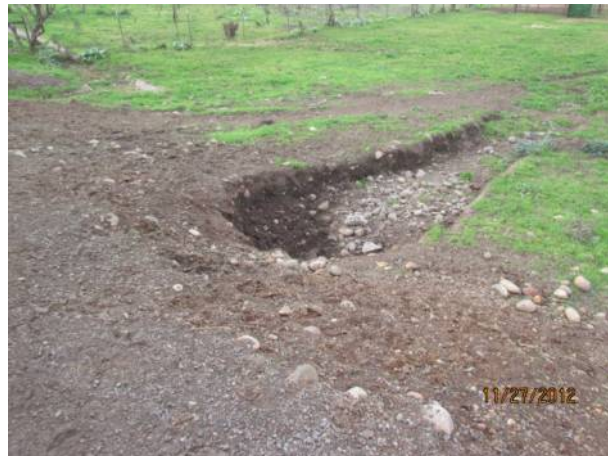
Levee Mile Report Line	17
Start Levee Mile	3.74
End Levee Mile	3.74
Location	Land Side
Category	
Item	Encroachments

View of the ditch along the waterside toe.

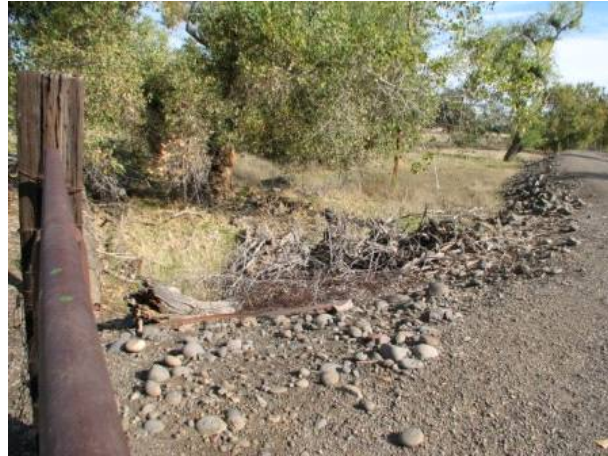
Levee Mile Report Line	1
Start Levee Mile	0.31
End Levee Mile	0.31
Location	Land Side
Category	
Item	Encroachments

View of debris & wire at toe of levee.

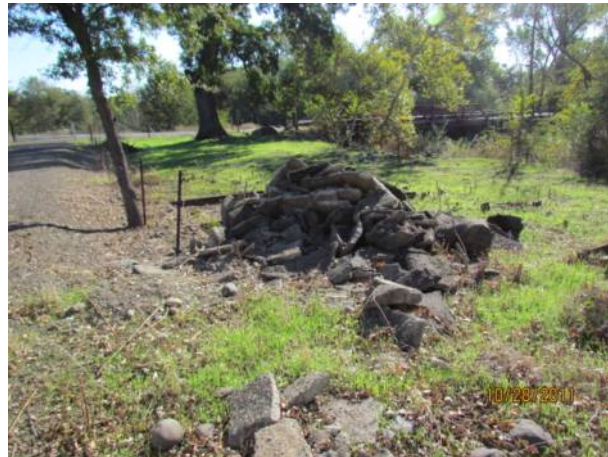
Levee Mile Report Line	2
Start Levee Mile	0.34
End Levee Mile	0.34
Location	Water Side
Category	
Item	Encroachments

View of the concrete pile along the W/S toe.

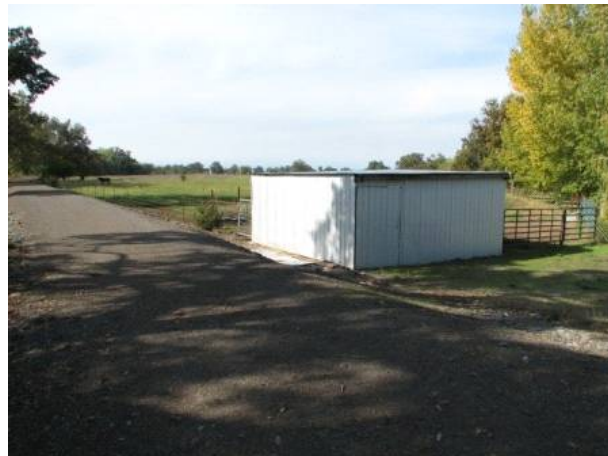
Levee Mile Report Line	3
Start Levee Mile	0.36
End Levee Mile	0.36
Location	Land Side
Category	
Item	Encroachments

View of building at toe of levee.

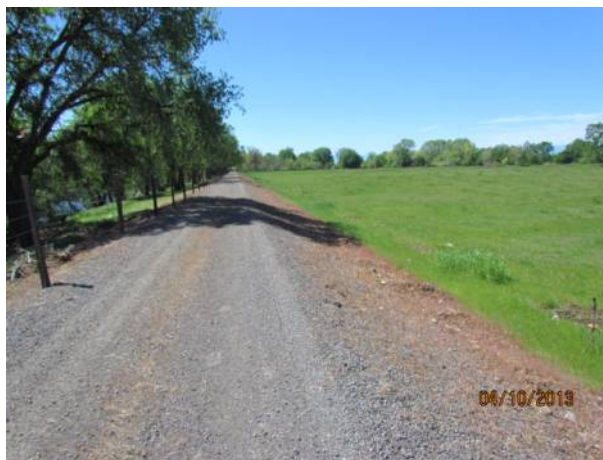
Levee Mile Report Line	5
Start Levee Mile	1.06
End Levee Mile	1.06
Location	Land Side
Category	
Item	Vegetation

View of the levee with no vegetation on both slopes.

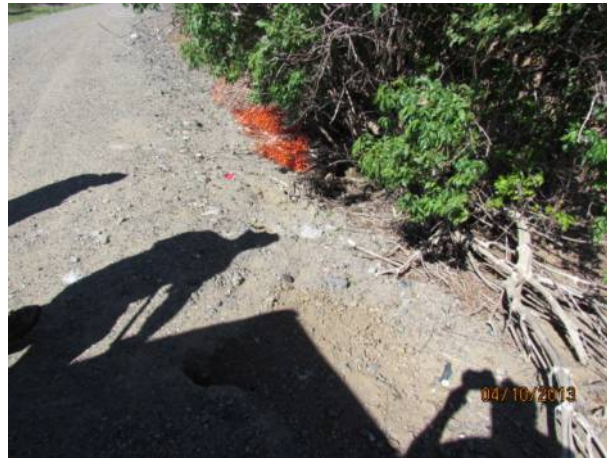
View of the rodent holes along the landside slope.

LMR No.	Levee Mile		Category	Item	Location	Rating	Action/Comment	GPS Latitude/Longitude		Issue No.
	Start	End						Start	End	
1	1.41	1.41		Animal Control	LS	M	A3 : No rodents visible, but rodent burrows visible; need to backfill and compact or grout burrows.	40.051517 ° -122.164850 °	40.051517 ° -122.164850 °	8 Y
						Ma				
										DWR ID: DWR_NA0019_04_s_2013_8
2	1.44	1.51	Supplemental	USACE Erosion Survey	WS	M	Inspector Comments: 2006 - High vertical bank due to mass failures. Thalweg meandering and erosion of bank. Banks are cohesive with non-cohesive gravel horizons. 2011 - Foundation is silty-sand with gravel. New slumping at the toe, mass failure continues. 2012: Site is part of the extended inventory, last inspected 2011. [2012 Site ID: ELC_1-4_L]	40.051596 ° -122.164179 °	40.051979 ° -122.163106 °	9 Y
						Ma				
										DWR ID: DWR_NA0019_04_s_2013_9
3	1.60	1.71		Slope Stability	WS	M	S3 : Repair the levee slope damaged by vehicle traffic and prevent access where possible. Inspector Comments: Tehama Co. repaired the slope that was damaged by vehicle traffic, but the damage has returned.	40.052607 ° -122.161418 °	40.053558 ° -122.159903 °	3 Y

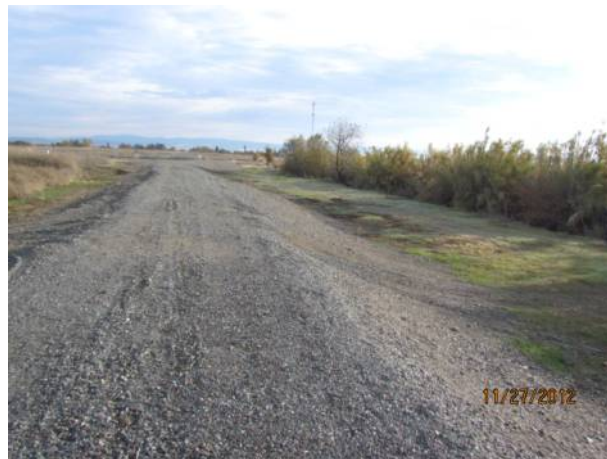
Levee Mile Report Line	3
Start Levee Mile	1.60
End Levee Mile	1.71
Location	Water Side
Category	
Item	Slope Stability

View of the levee slopes damaged by vehicle traffic.

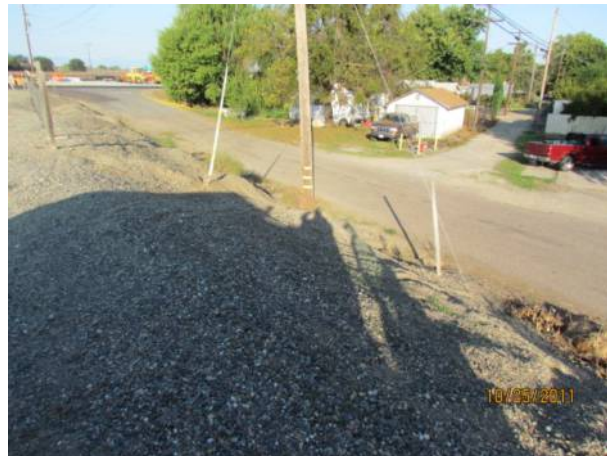
Levee Mile Report Line	4
Start Levee Mile	2.32
End Levee Mile	2.32
Location	Land Side
Category	
Item	Slope Stability

View of the vehicle erosion along the L/S slope.

Ma				
										DWR ID: DWR_04_s_2012_3
4	2.32	2.32		Slope Stability	LS	M	S3 : Repair the levee slope damaged by vehicle traffic and prevent access where possible.	40.052415 ° -122.149208 °	40.052415 ° -122.149208 °	18 Y
						Ma				
										DWR ID: DWR_NA0019_04_s_2012_18
5	2.46	2.46		Slope Stability	LS	M	S3 : Repair the levee slope damaged by vehicle traffic and prevent access where possible.	40.052417 ° -122.146747 °	40.052417 ° -122.146747 °	20 Y
						Ma				
										DWR ID: DWR_NA0019_04_s_2012_20
6	2.53	2.53		Slope Stability	LS	M	S3 : Repair the levee slope damaged by vehicle traffic and prevent access where possible.	40.052872 ° -122.145495 °	40.052872 ° -122.145495 °	2 Y
						Ma				
										DWR ID: DWR_NA0019_04_s_2012_2
7	2.66	2.66		Encroachments	LS	M	DE : Debris	40.054352 ° -122.144245 °	40.054352 ° -122.144245 °	4 Y
						Ma				
										DWR ID: DWR_NA0019_04_s_2012_4
8	2.82	2.85		Slope Stability	LS	M	S3 : Repair the levee slope damaged by vehicle traffic and prevent access where possible.	40.055033 ° -122.141457 °	40.055595 ° -122.141203 °	916 Y

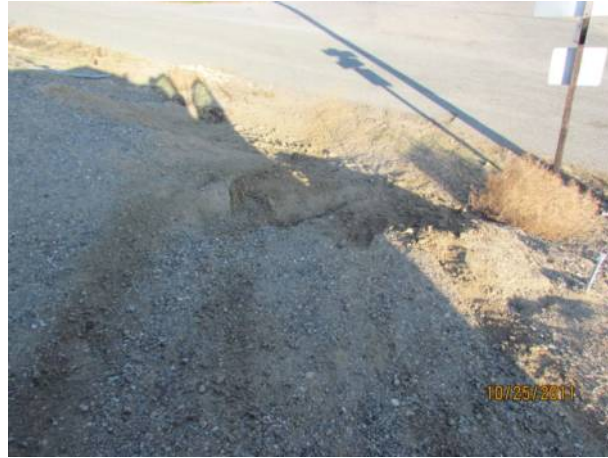
View of the vehicle erosion along the L/S slope.

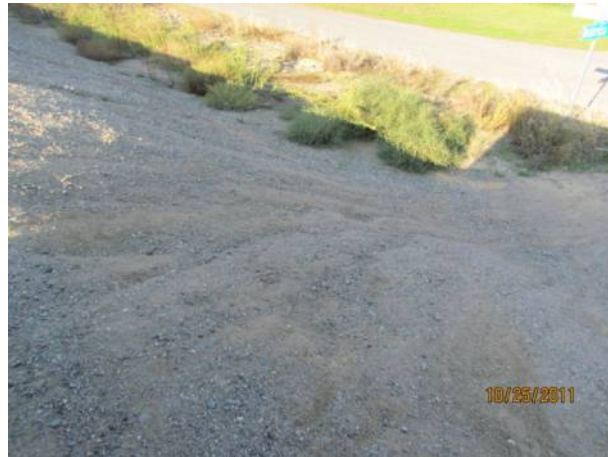
Levee Mile Report Line	6
Start Levee Mile	2.53
End Levee Mile	2.53
Location	Land Side
Category	
Item	Slope Stability

View of the vehicle erosion along the L/S slope.

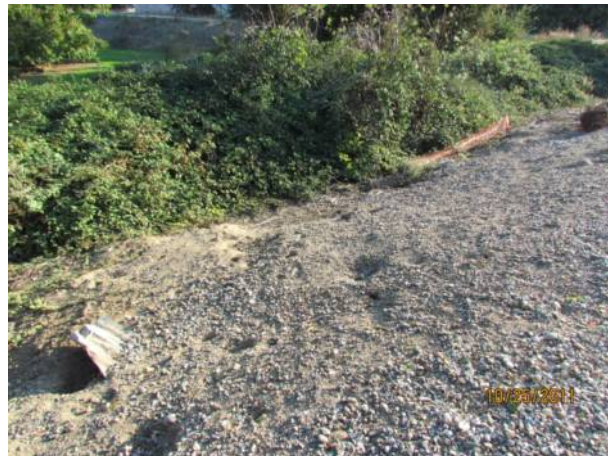
Levee Mile Report Line	9
Start Levee Mile	3.02
End Levee Mile	3.02
Location	Land Side
Category	
Item	Animal Control

View of the rodent holes along the L/S slope.

Ma				
										DWR ID: DWR_NA0019_04_s_2012_916
9	3.02	3.02		Animal Control	LS	M	A3 : No rodents visible, but rodent burrows visible; need to backfill and compact or grout burrows.	40.056514 ° -122.139449 °	40.056514 ° -122.139449 °	5 Y
						Ma				
										DWR ID: DWR_NA0019_04_s_2012_5
10	3.03	3.03		Encroachments	LS	M	PR : Prunings	40.056487 ° -122.139394 °	40.056487 ° -122.139394 °	13 Y
						Ma				
										DWR ID: DWR_NA0019_04_f_2012_13
11	3.03	3.03		Slope Stability	WS	M	S3 : Repair the levee slope damaged by vehicle traffic and prevent access where possible.	40.056388 ° -122.139168 °	40.056388 ° -122.139168 °	10 Y
						Ma				
										DWR ID: DWR_NA0019_04_s_2012_10
12	3.15	3.15		Encroachments	LS	M	ST : Stairway	40.057285 ° -122.137732 °	40.057285 ° -122.137732 °	1 Y
						Ma				
										DWR ID: DWR_NA0019_04_s_2012_1
13	3.34	3.34		Encroachments	LS	M	GA : Garbage	40.057558 ° -122.134417 °	40.057558 ° -122.134417 °	6 Y

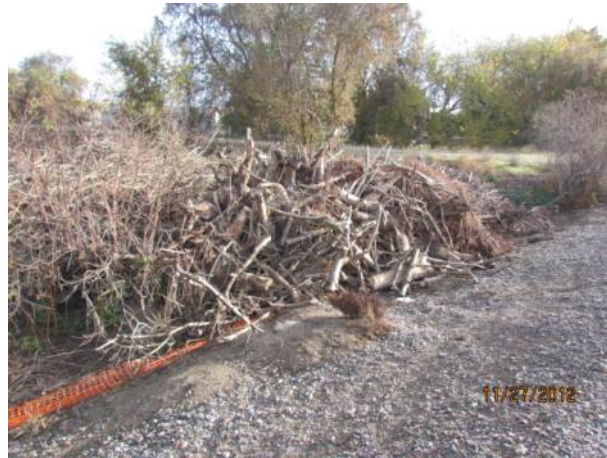
View of the brush pile next to the levee slope.

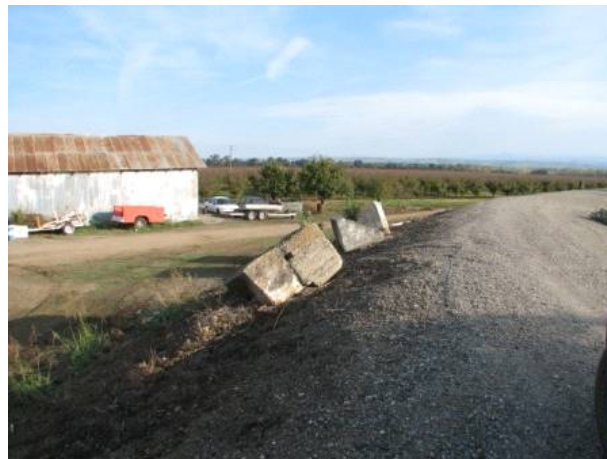
Levee Mile Report Line	12
Start Levee Mile	3.15
End Levee Mile	3.15
Location	Land Side
Category	
Item	Encroachments

View of the concrete stairways on the slope.

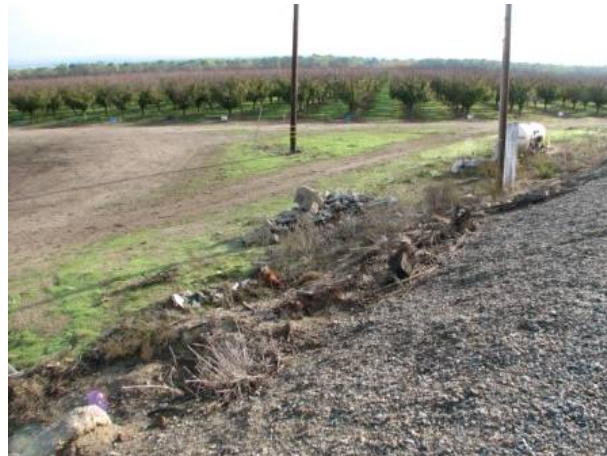
Levee Mile Report Line	13
Start Levee Mile	3.34
End Levee Mile	3.34
Location	Land Side
Category	
Item	Encroachments

View of the garbage and metal at the toe of the levee & along the slope of the landside.

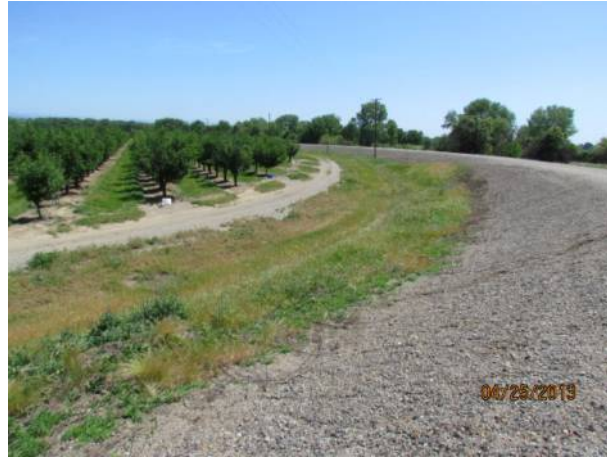
View of the ditch along landside toe.

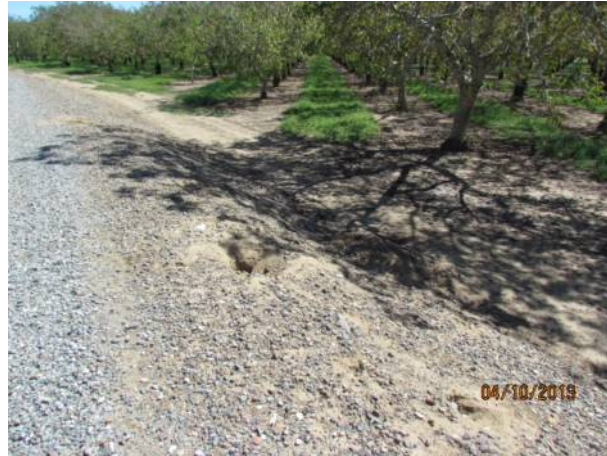
View of the rodent holes along the levee slope.

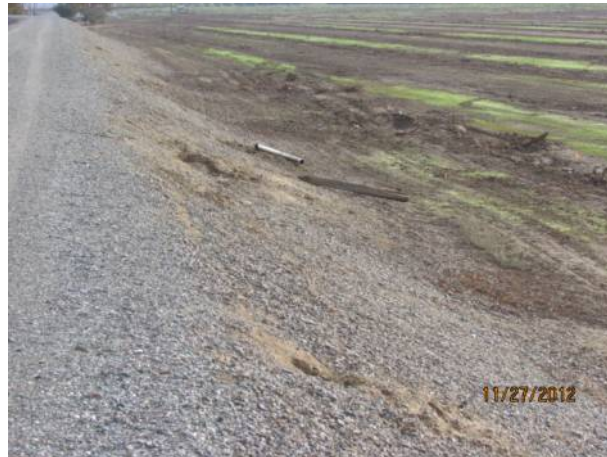
Levee Mile Report Line	3
Start Levee Mile	2.55
End Levee Mile	2.55
Location	Water Side
Category	
Item	Animal Control

View of the rodent activity along the landside slope.

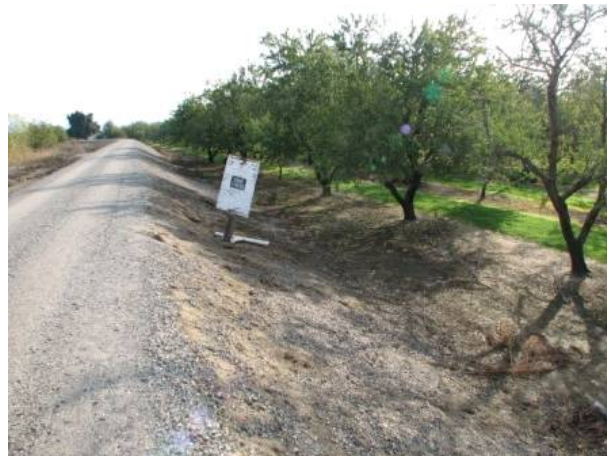
Levee Mile Report Line	4
Start Levee Mile	2.57
End Levee Mile	2.57
Location	Land Side
Category	
Item	Animal Control

View of the bait station next to the squirrel holes on the landside slope.

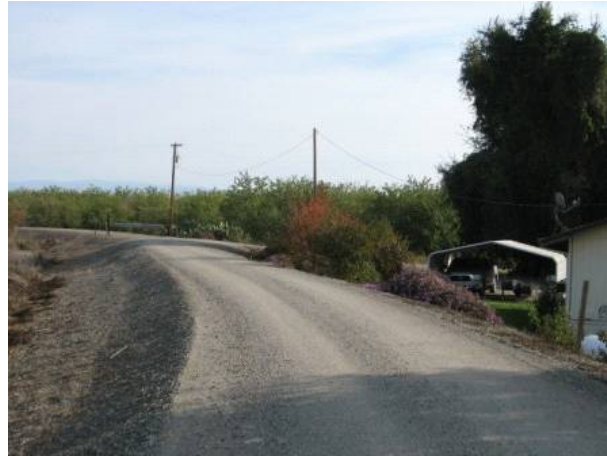
View of the landscape along the slope.

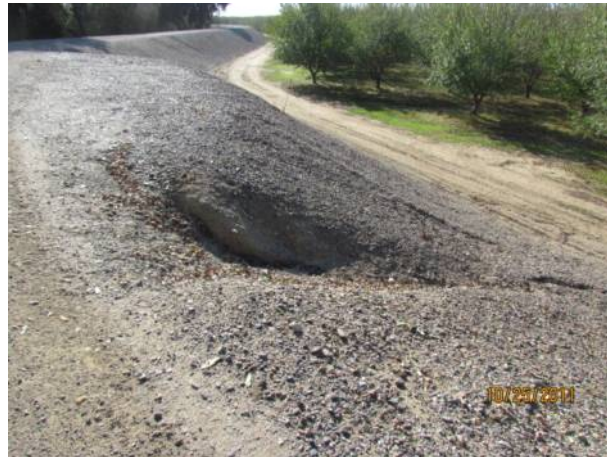
Levee Mile Report Line	9
Start Levee Mile	3.45
End Levee Mile	3.45
Location	Land Side
Category	
Item	Erosion / Bank Caving

View of the erosion along the L/S slope.
